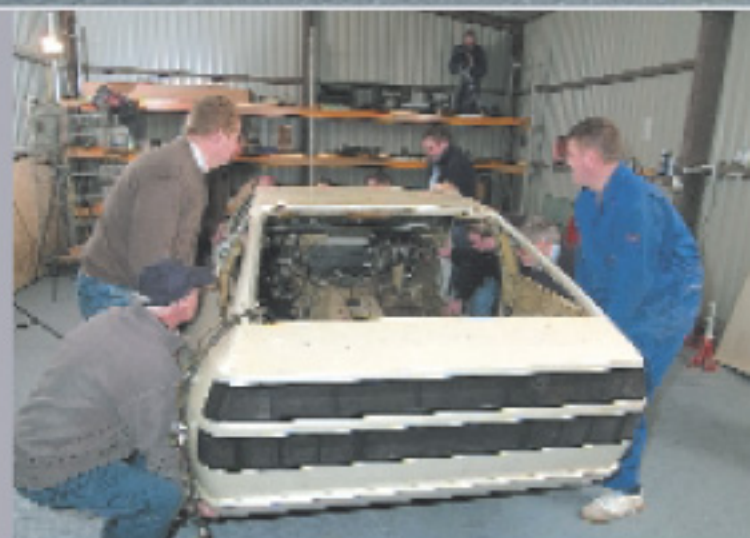
"pulling the fuel lines through and disconnecting the engine bay ancillaries was next on the list, followed by a comprehensive search for rogue earth straps and cable lies. This may sound like an obvious and mundane job, but the heated rear screen was actually earthed via an eleven foot piece of wire direct to the coil – yes really!"
