www.tvrwhiteelephant.co.uk

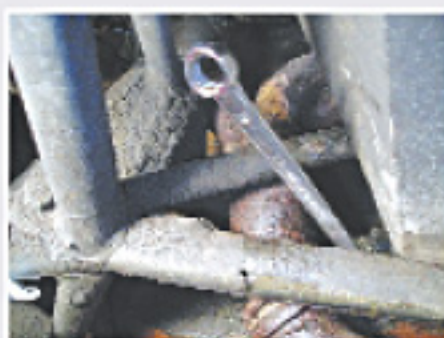
November's jobs should have started with removing the wheels to enable us to drop the steering column. This proved more difficult than first expected, as the wheel centres and OZ security screws were heavily corroded in. After a fortnight of subtleties, and having machined and broken several home-made steel extraction tools, we eventually resorted to drilling the security screws out. So off the wheels came, closely followed by the column.
